Case study: Longwall face alignment

Application: *Underground coal*
Location: *Illinois-basin, United States*
Products featured: *Joy 7LS, PRS*

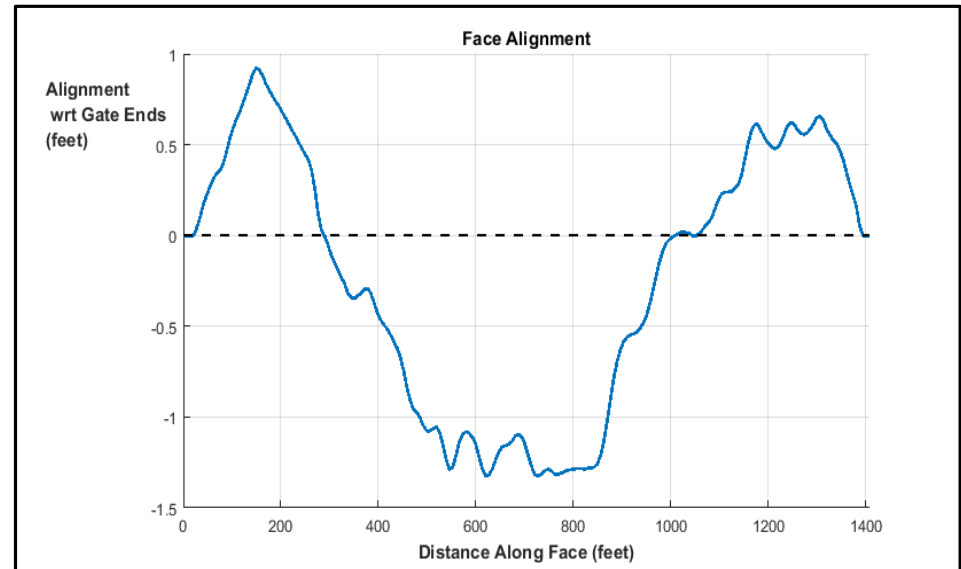
Challenge: Face misalignment

Maintain longwall face alignment without the need for human intervention and string-lines.

Correct face alignment maintains **production efficiency** and **safe roof** conditions.

Contributing factors:

- Wide coal face (1400ft)
- Varying roof conditions
- Varying entry width development
- Varying seem roll

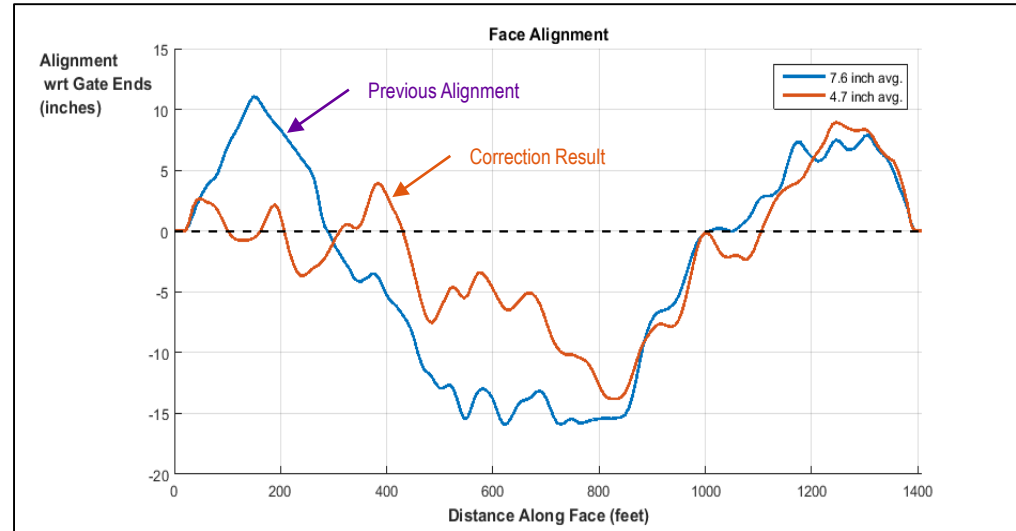
Solution: Automated face alignment correction

Development of automated process to align the longwall face.

Process gradually brings face back into alignment.

Prevents drastic changes but improves towards ideal conditions

Removes additional personnel through automated process

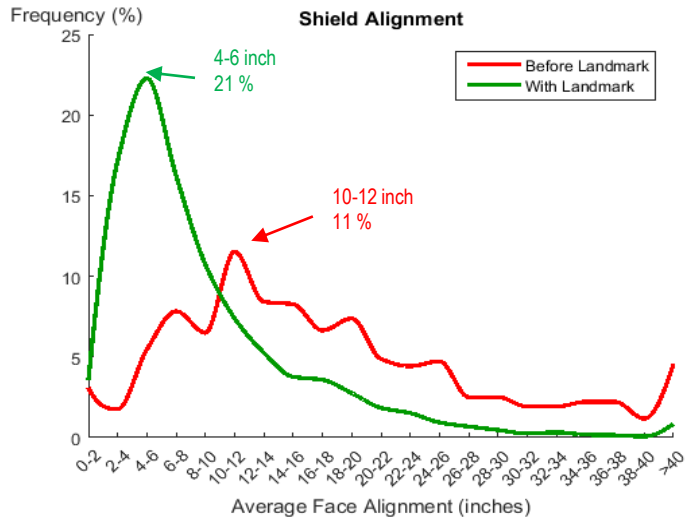
Results:

↑ 31 % Improvement in Average Face Alignment.

↑ 66 % Improvement in Face Aligning Cuts

↑ 57 % Improvement in Gate Aligning Cuts
