Case study:

Cost savings by improving powered roof support performance

Application: *Coal*

Products featured: *Powered roof supports*

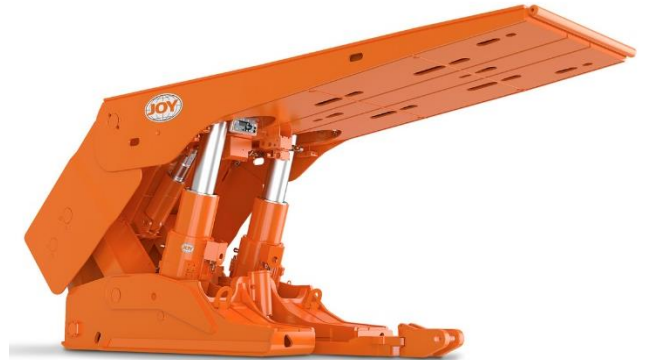
Challenge: Deterioration of PRS performance

Hydraulic integrity of roof support systems is critical to optimal performance. Failure of the equipment to meet required setting pressures within a certain time results in poor roof conditions and the formation of cavities. This in turn means reduced production rates, and even total production outages whilst remedial work is carried out.

- Reducing PRS performance
- Requirement to operate at consistent retreat rates
- Major rebuild work could not be effected until the end of the LW block

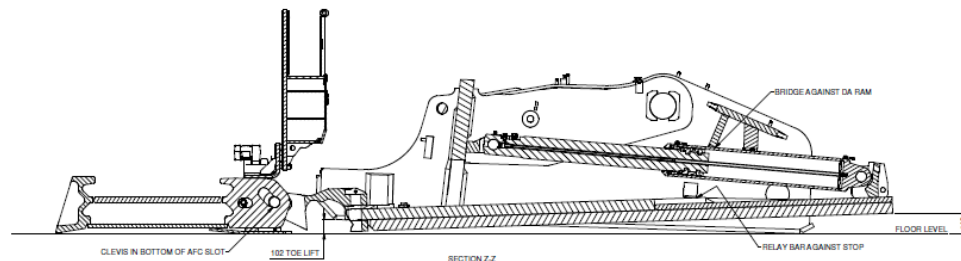
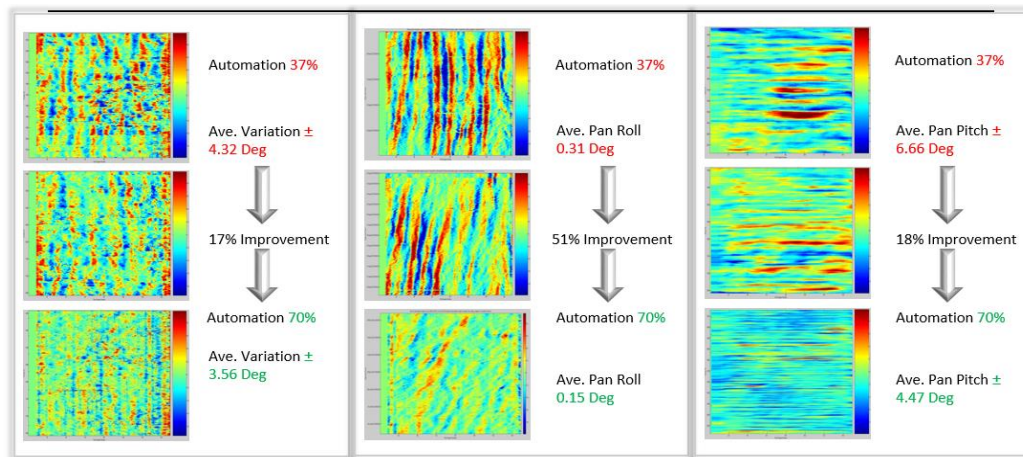
Monitoring was focused on pump system KPI's and reporting developed to graphically represent findings

Root cause identified as poor horizon control leading to equipment interference in extreme cases and subsequent damage

Notifications sent for remedial actions when operating outside envelope

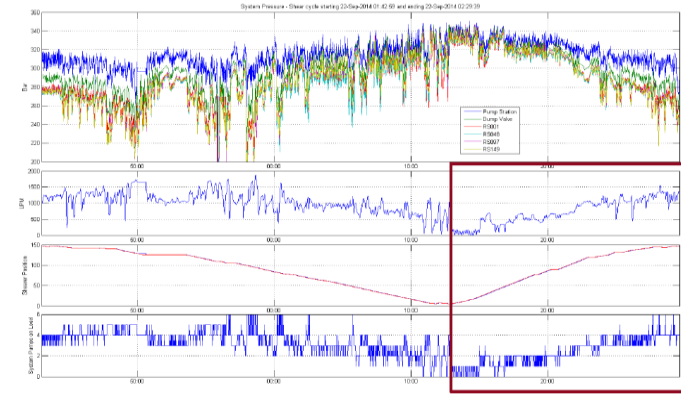
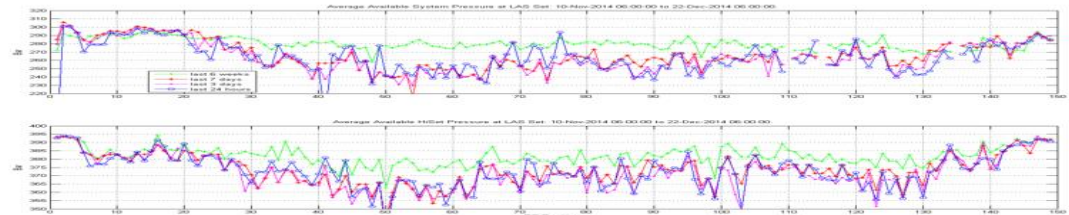
Improved monitoring and reporting conditions to identify equipment failure earlier and manage appropriately.

Any additional equipment showing signs of potential failure was also identified immediately and spares / change out rectification maintenance scheduled to reduce the risk of failure in service

During the LW move modifications were carried out to all PRS to remove any potential interference points as well as overhauling critical components

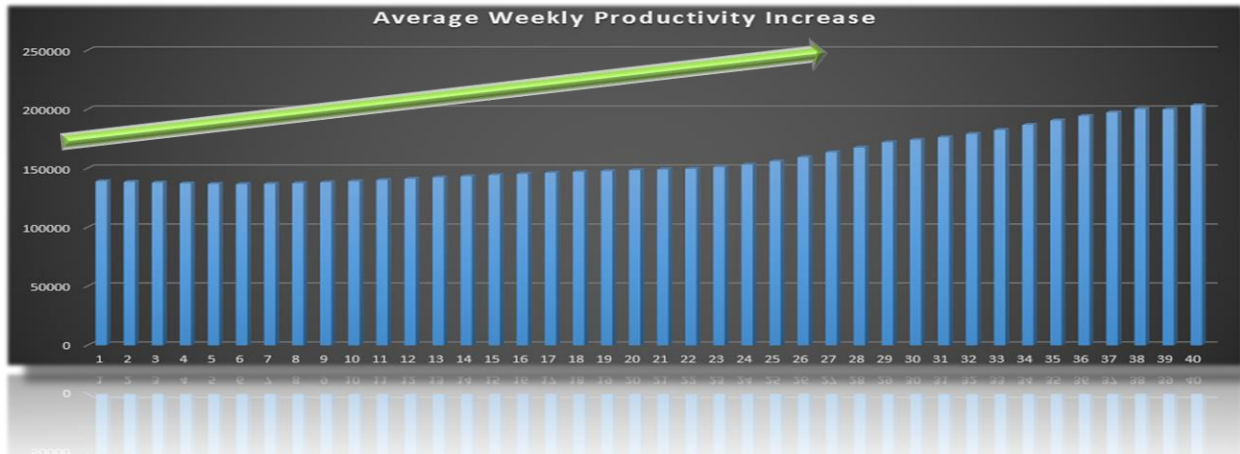
24% increase in average weekly operating hours

16% increase in average tonnes per operating hour

39% increase in average weekly output
