## Preventing conveyor system downtime

Monitoring systems detected excessive startup torque on a 4,200-foot Joy underground-to-surface conveyor system at an Illinois coal operation. Site operators needed the issue resolved quickly to avoid months of potential downtime, as the system is the main production artery for the mine.

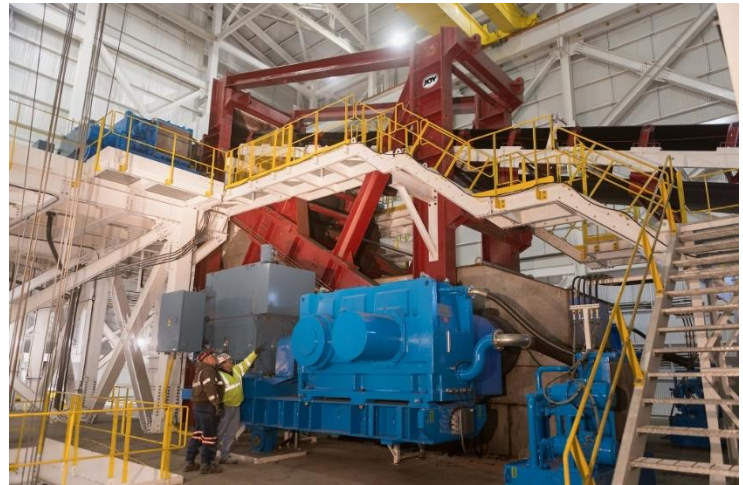
Smart Solutions experts took baseline readings of the system during commissioning to enable flawless startup.

Once the system was in regular operation excessive startup torque was detected during the continued monitoring. The Smart team then used those baseline readings to quickly target the problem area.

Personnel then immediately went to the site to investigate the problem area with handheld vibration monitors and confirmed there was excessive vibration on the head drive pulley due to a faulty coupling.

Zero of the four gearboxes were damaged by the excessive vibration, saving the customer months of costly downtime and the potential for \$2 million in gearbox replacements. The issue was fixed during a scheduled maintenance period, eliminating the need for any unplanned downtime and allowing nonstop production at the site.
